MEMORANDUM
DEVELOPMENT SERVICES/BUILDING DEPARTMENT

SUBJECT: TARGET ROOF PV FIRE OF 4-5-09
9100 ROSEDALE HWY BAKERSFIELD, CALIFORNIA

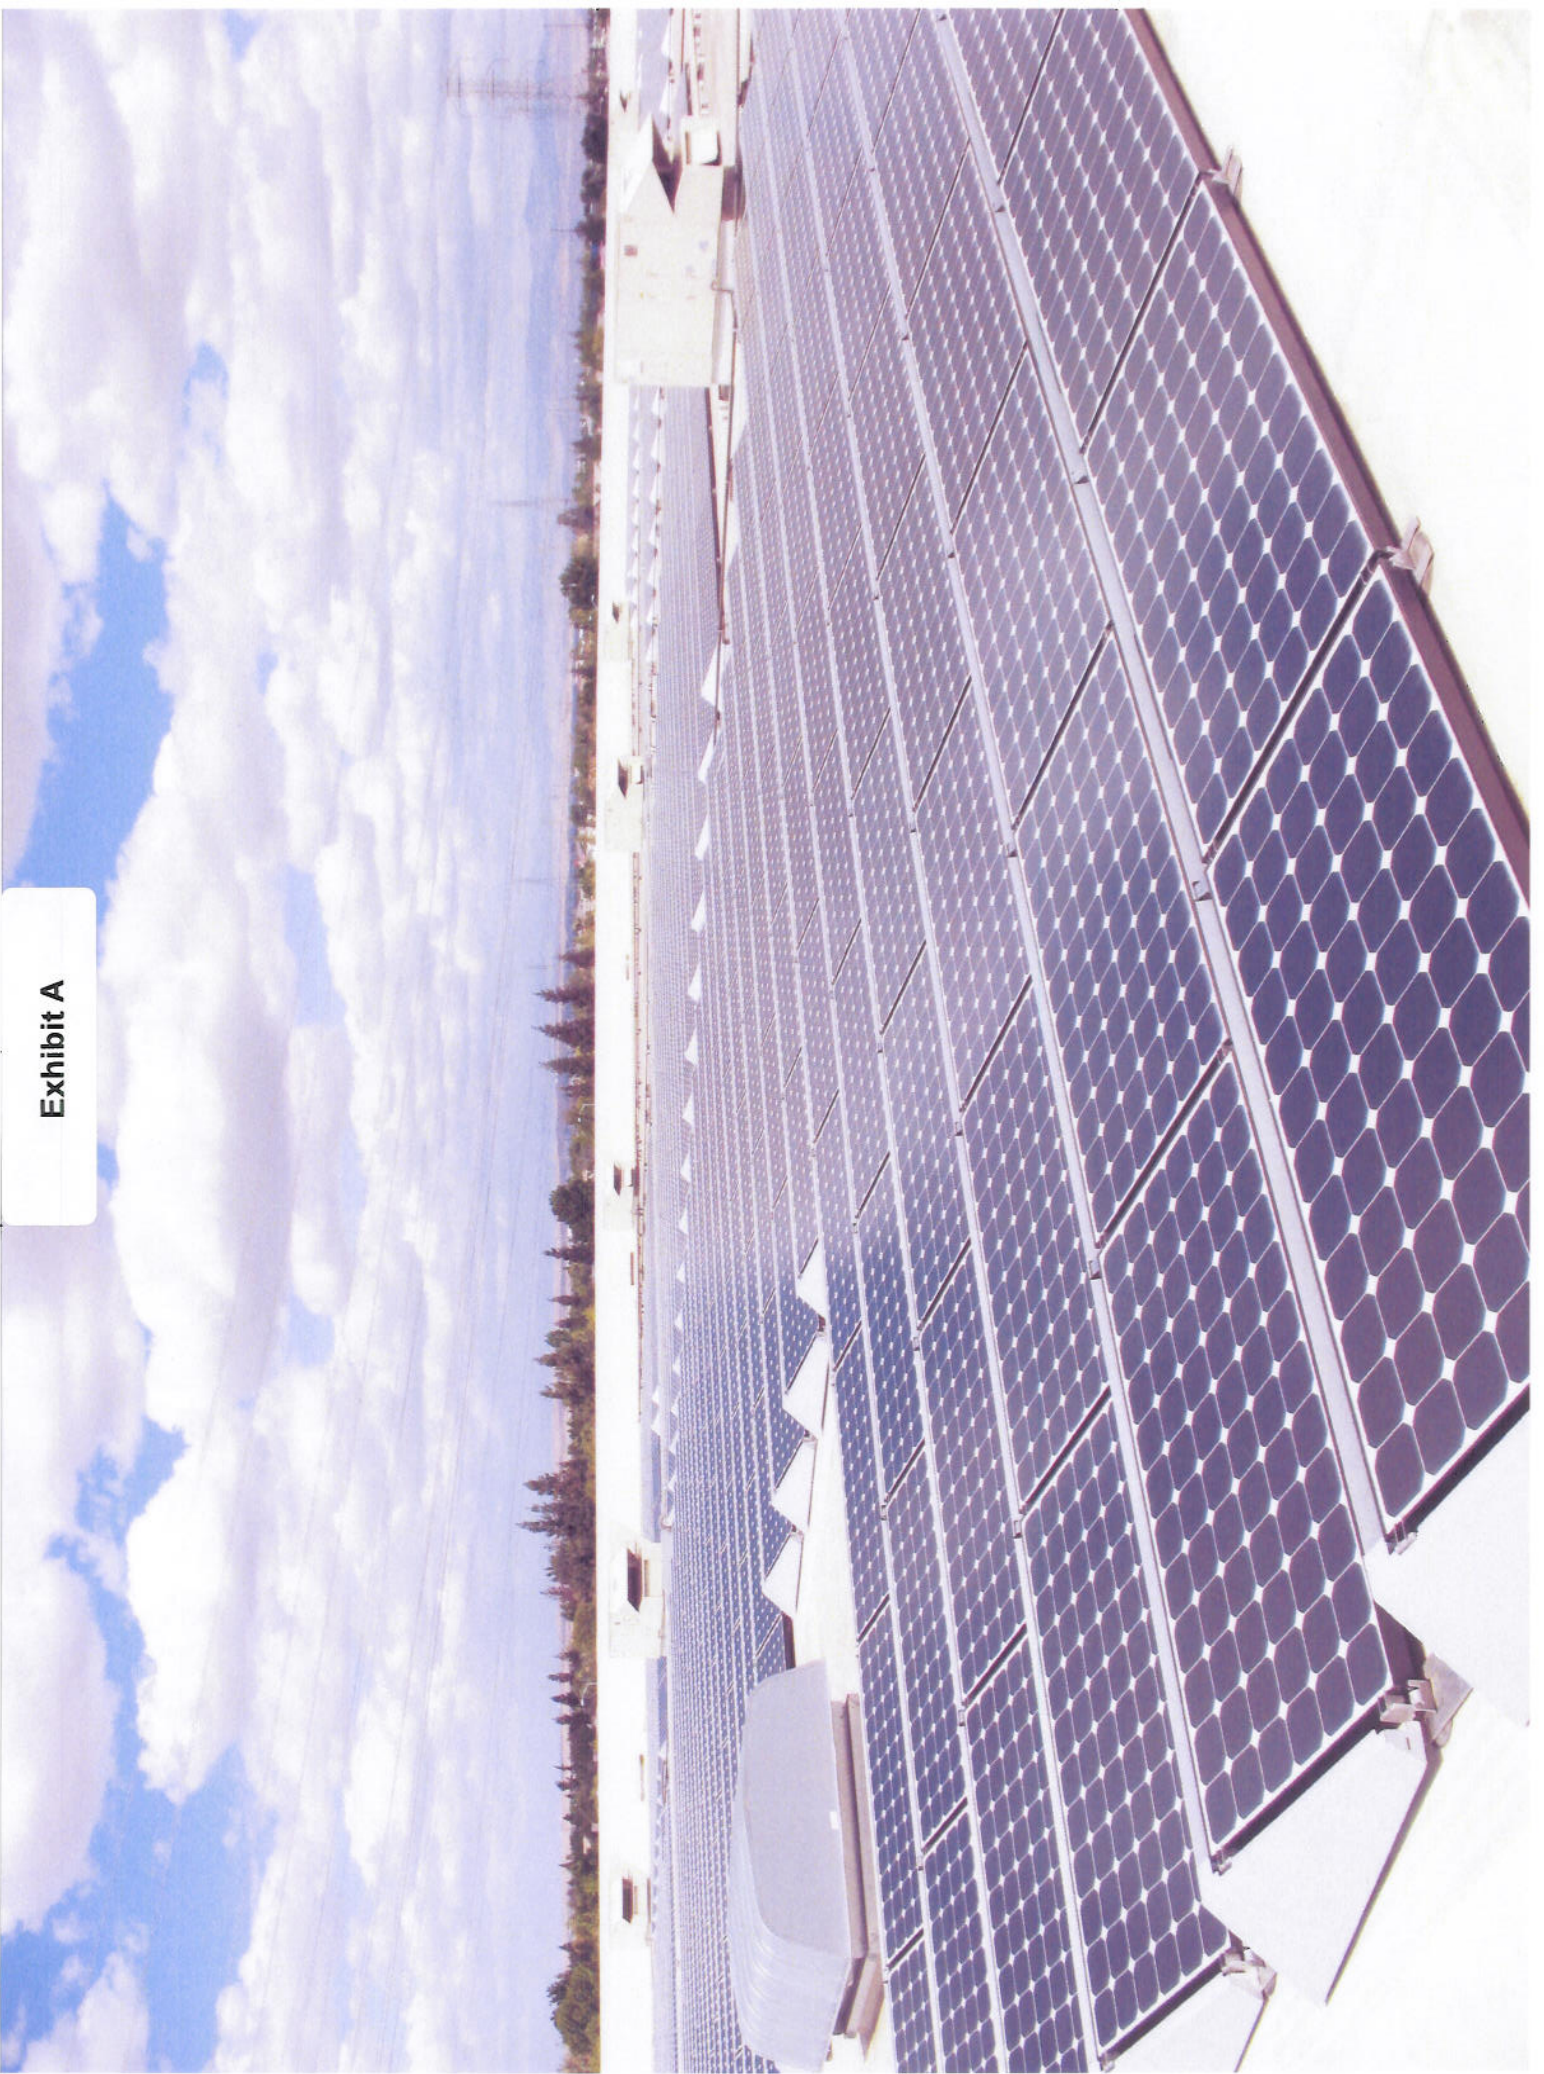
Exhibit A

Based on the City of Bakersfield approved plans of 1-29-08, the PV system on the Target store at 9100 Rosedale Hwy consists of 1826 Sunpower SPR-210-WHT photovoltaic modules arranged in 166 strings of 11 modules. The strings are connected to the two Xantrex inverters through four fused combiner boxes (two 30 string, one 50 string and one 56 string). The strings are individually fused with 12 amp fuses. The string short circuit current (Isc) is 5.75 amps and the open circuit voltage (Voc) is 575 Vdc. String operating current is 5.25 amps. String operating voltage is 440 Vdc. **See Exhibits A and B.**

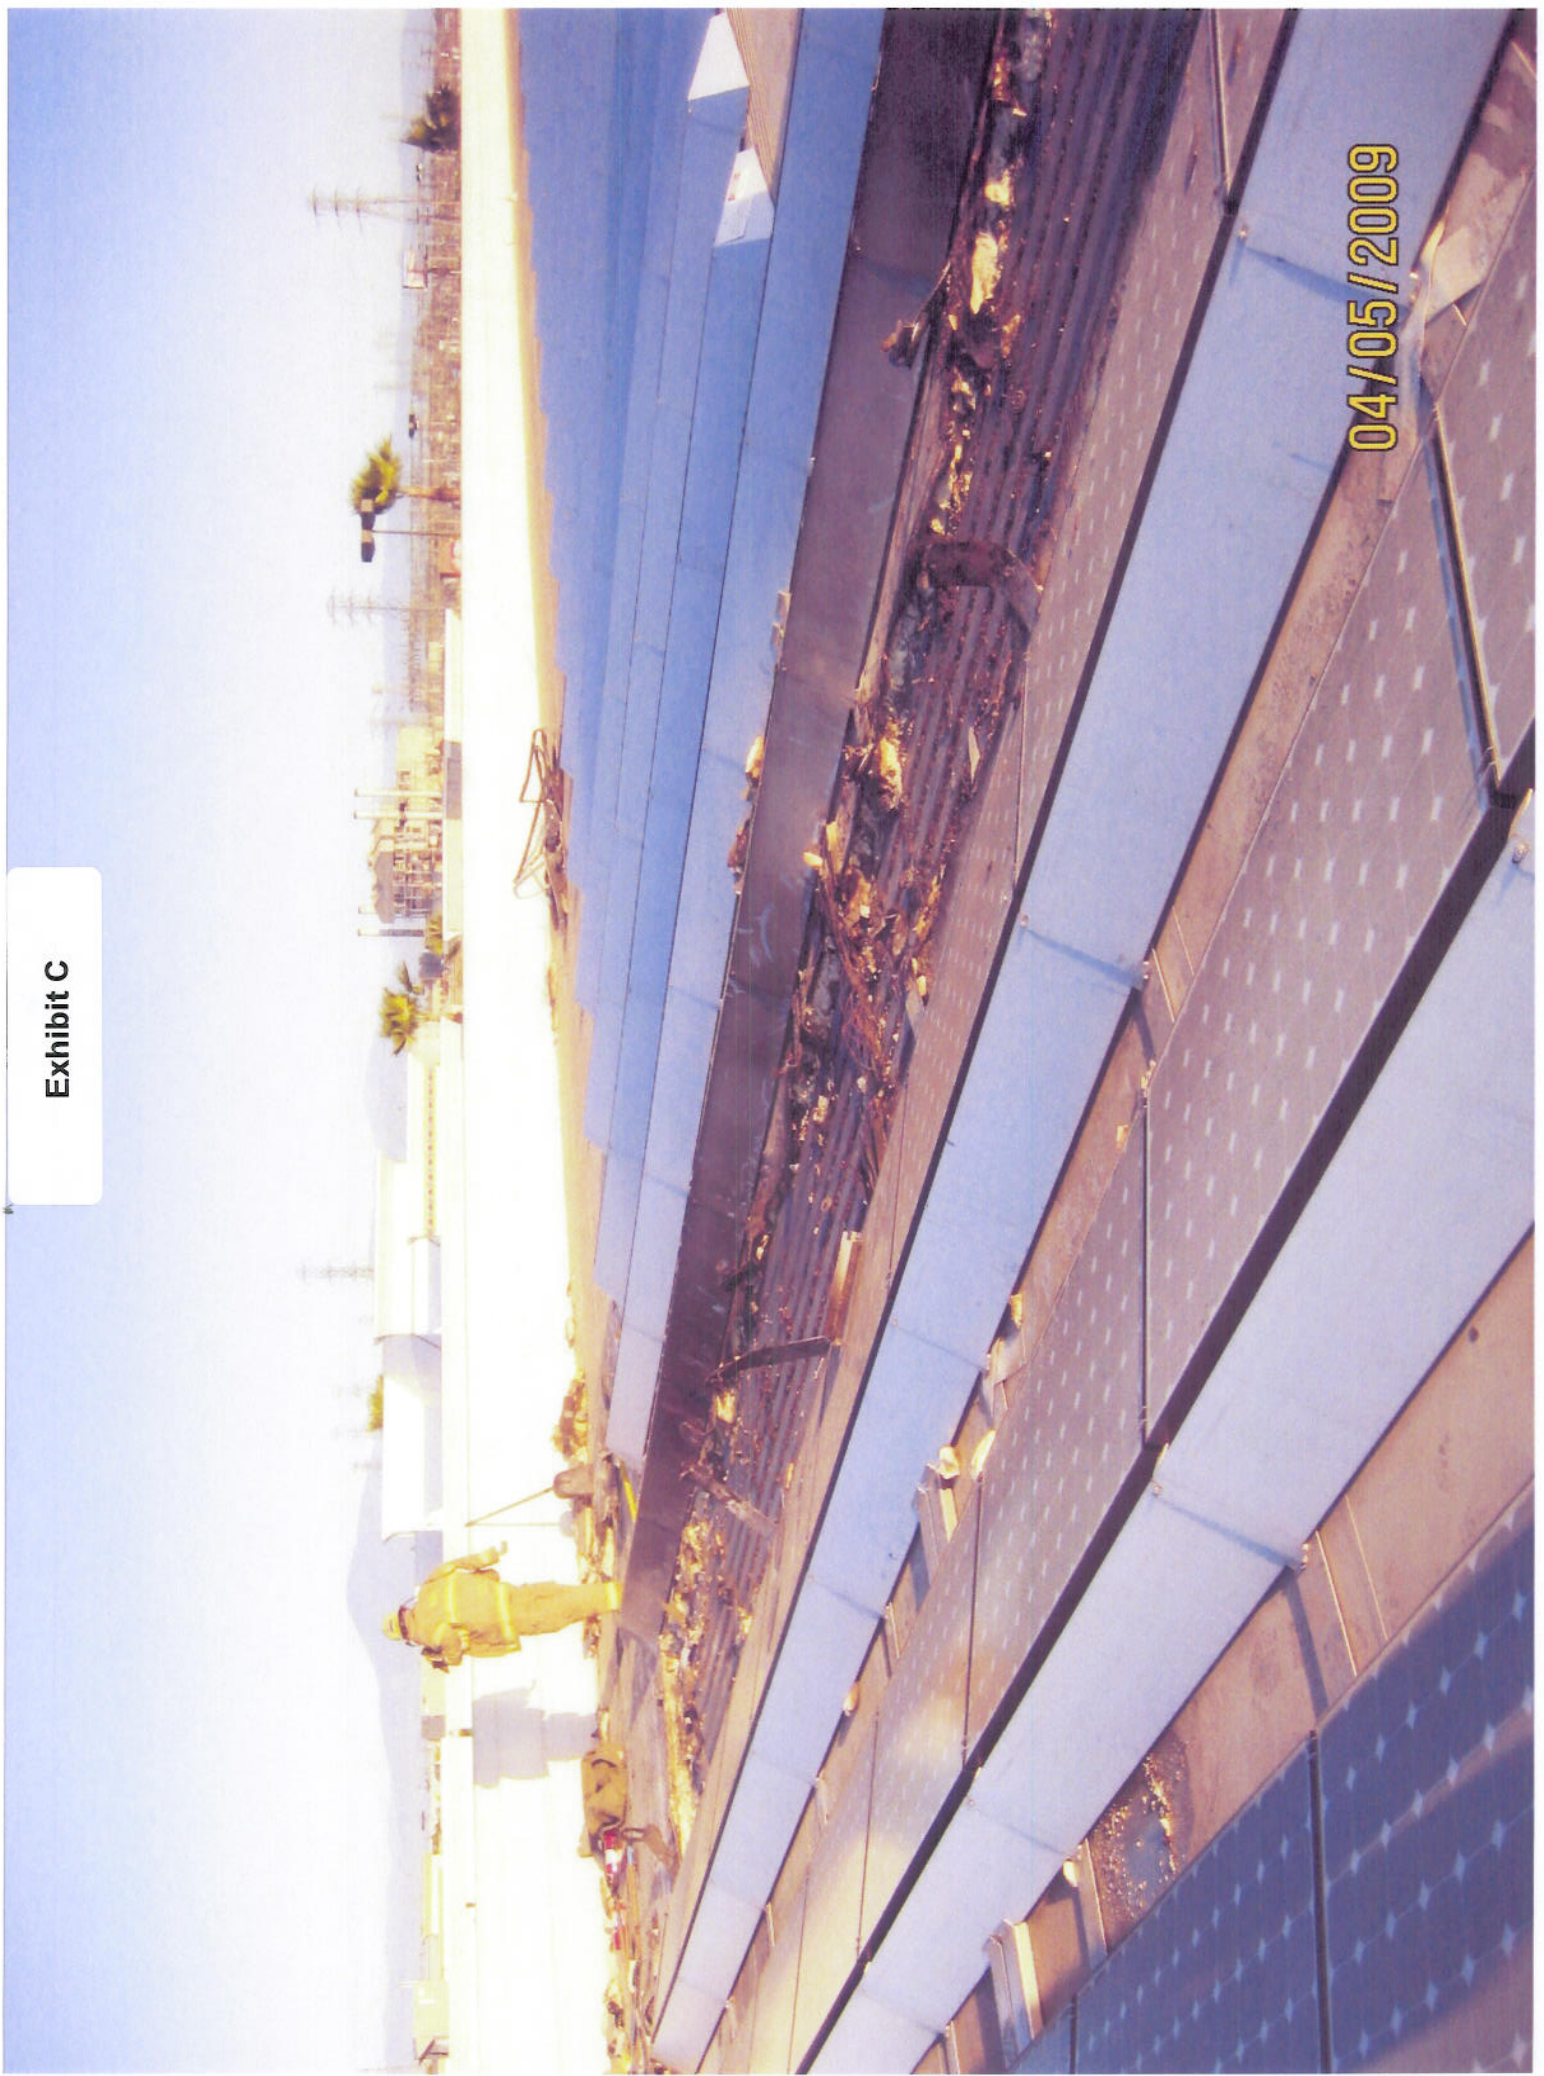
Exhibit C

The fire involved modules connected to Combiner Box 1 and the three inch EMT conduit with four #500 KCMIL (two positive and two negative) and a #3/0 AWG equipment grounding conductor which is the output from Combiner Box 1 to the fused DC disconnect for the 225kw (System A) inverter. The smaller inverter (System B) and associated modules were not involved. **See Exhibits C, D, E, F, G and H.**

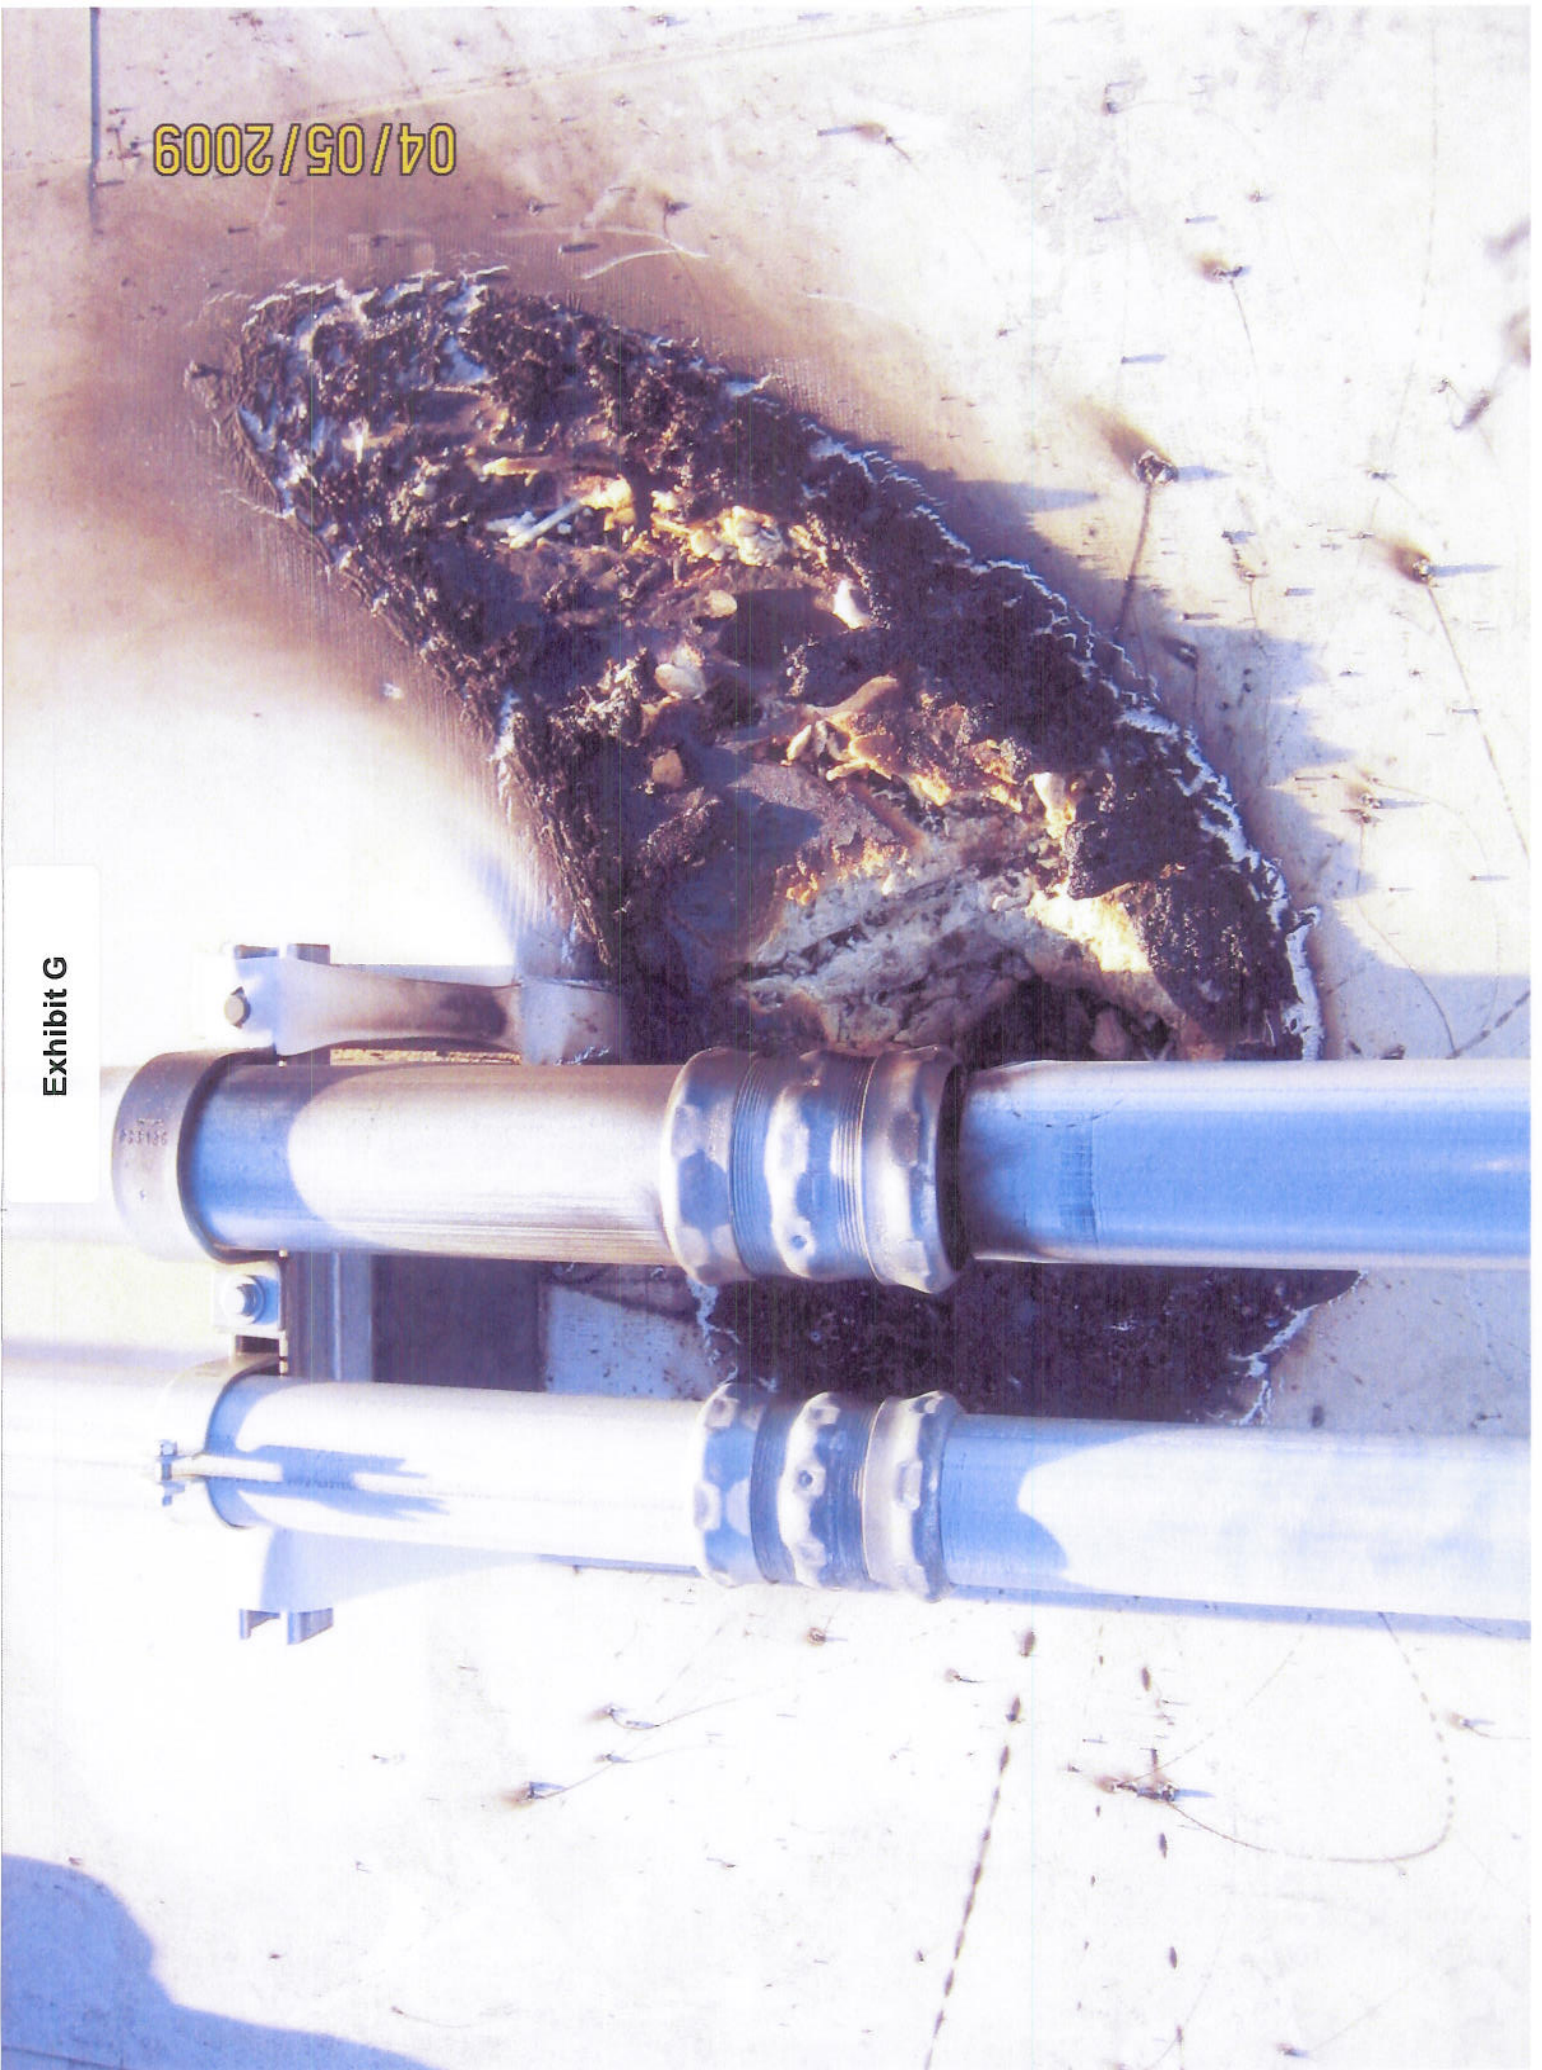
Exhibit G

All remaining string voltages were normal (465 – 475 Vdc)
- 3) The equipment grounding lugs in this combiner box (as well as all of the others) are labeled for use with the conductor sizes #500 KCMIL - #4 AWG. The equipment grounding conductor from the combiner box to the PV module is #6 AWG.
- 4) A massive arc occurred in the three inch EMT conduit at a coupling 228' from Combiner Box A1. This conduit contained two #500 KCMIL positive and two #500 KCMIL negative conductors as well as a #3/0 AWG equipment grounding conductor. These paralleled conductors carry the current from Combiner Box A1 to the fused DC disconnect and inverter in the equipment yard. **This conduit is inserted approximately 1/2" into the compression coupling at this point. A complete insertion would require 3". A coupling in the**

conduit next to this one (from another combiner box) was loose (can be turned by hand). All other couplings were checked and were found to be at least "hand tight". **See Exhibits G and H.**

The three inch EMT conduit either separated or was never fully inserted during installation. There are marks on the end of the conduit which occur when the compression coupling is installed. This would indicate that the conduit was completely seated in the coupling when first installed. Massive arcing between the grounded and ungrounded conductors along with arcing to the equipment grounding conductor and EMT conduit was a cause of the roof fire at this location. The coupling here is destroyed along with the conduit. **It should be noted that during the post fire inspection of 4-6-09 the coupling in the conduit next to the faulted conduit was not "wrench" tight – not even "hand" tight.** It is probable that the coupling in the faulted conduit may not have been "hand" tight as well. Conductor insulation damage is very possible either during installation or over time. There is not any indication of damage or deflection of this conduit from outside

An O-Z GEDNEY AX series expansion coupling was installed 198 feet from Combiner Box A1 (30 feet from the conduit separation). This expansion coupling was not specified to be installed as a part of the design. **This fitting is not listed for use with EMT conduit.** It is intended to be used with RMC or IMC only (threaded conduit systems). The manufacturer produces another fitting for use with EMT. In addition, a mixture of different straps were used to secure the conduit to the UNITSTRUT topped blocks on the roof surface. A total of 24 POWERSTRUT PS1100 STD straps were used which would not allow movement of the conduit on its support blocks. One POWERSTRUT PS 3126 strap and nineteen UNISTRUT P 255830 straps were installed which may have allowed some movement since washers were installed under the clamps to provide annular space around the conduit. A review of the manufacturer's literature for both products did not indicate that the products were intended to be used for applications where movement in the conduit would be needed. **Both B-LINE and UNISTRUT (manufacturers of conduit straps) specify both a one-piece strap which is one pipe size larger than the conduit used or a two piece strap with an insert between the strap and pipe which allows conduit movement in their product catalogs. A B-LINE representative who visited the site confirmed this as well.** The conduits are all supported and secured on the roof by recycled rubber blocks which have a UNISTRUT type of channel for connection of the pipe straps. These blocks are then attached to the roof membrane by strapping (made with the roof material) to the roof itself in accordance with the roofing product standards. These roof support blocks are not designed to slide or move on this roof. If movement is to occur it should occur with the conduit moving on the UNISTRUT topped blocks, not the rubber blocks moving on the PVC roof. **The conduit had an expansion and contraction linear movement of 3.7 inches. The incorrect expansion fitting and straps could cause the movement to occur at one or more of the compression couplings. A loose coupling would very possibly experience the most movement. Conductor insulation damage is a likely result. Conductor insulation damage did occur here. There would be no faults without insulation damage at this point. See Exhibits G, H, L and M.**

- 1) High voltage insulation testing (megger) all of the existing system wiring and any new or repaired wiring per CEC 110.7.
- 2) The conduit systems installed on the roof need to be engineered for the thermal expansion which will occur per CEC (NEC) 300.7 (B) FPN. Expansion fittings and straps listed for the purpose and the conduit system installed must be utilized.

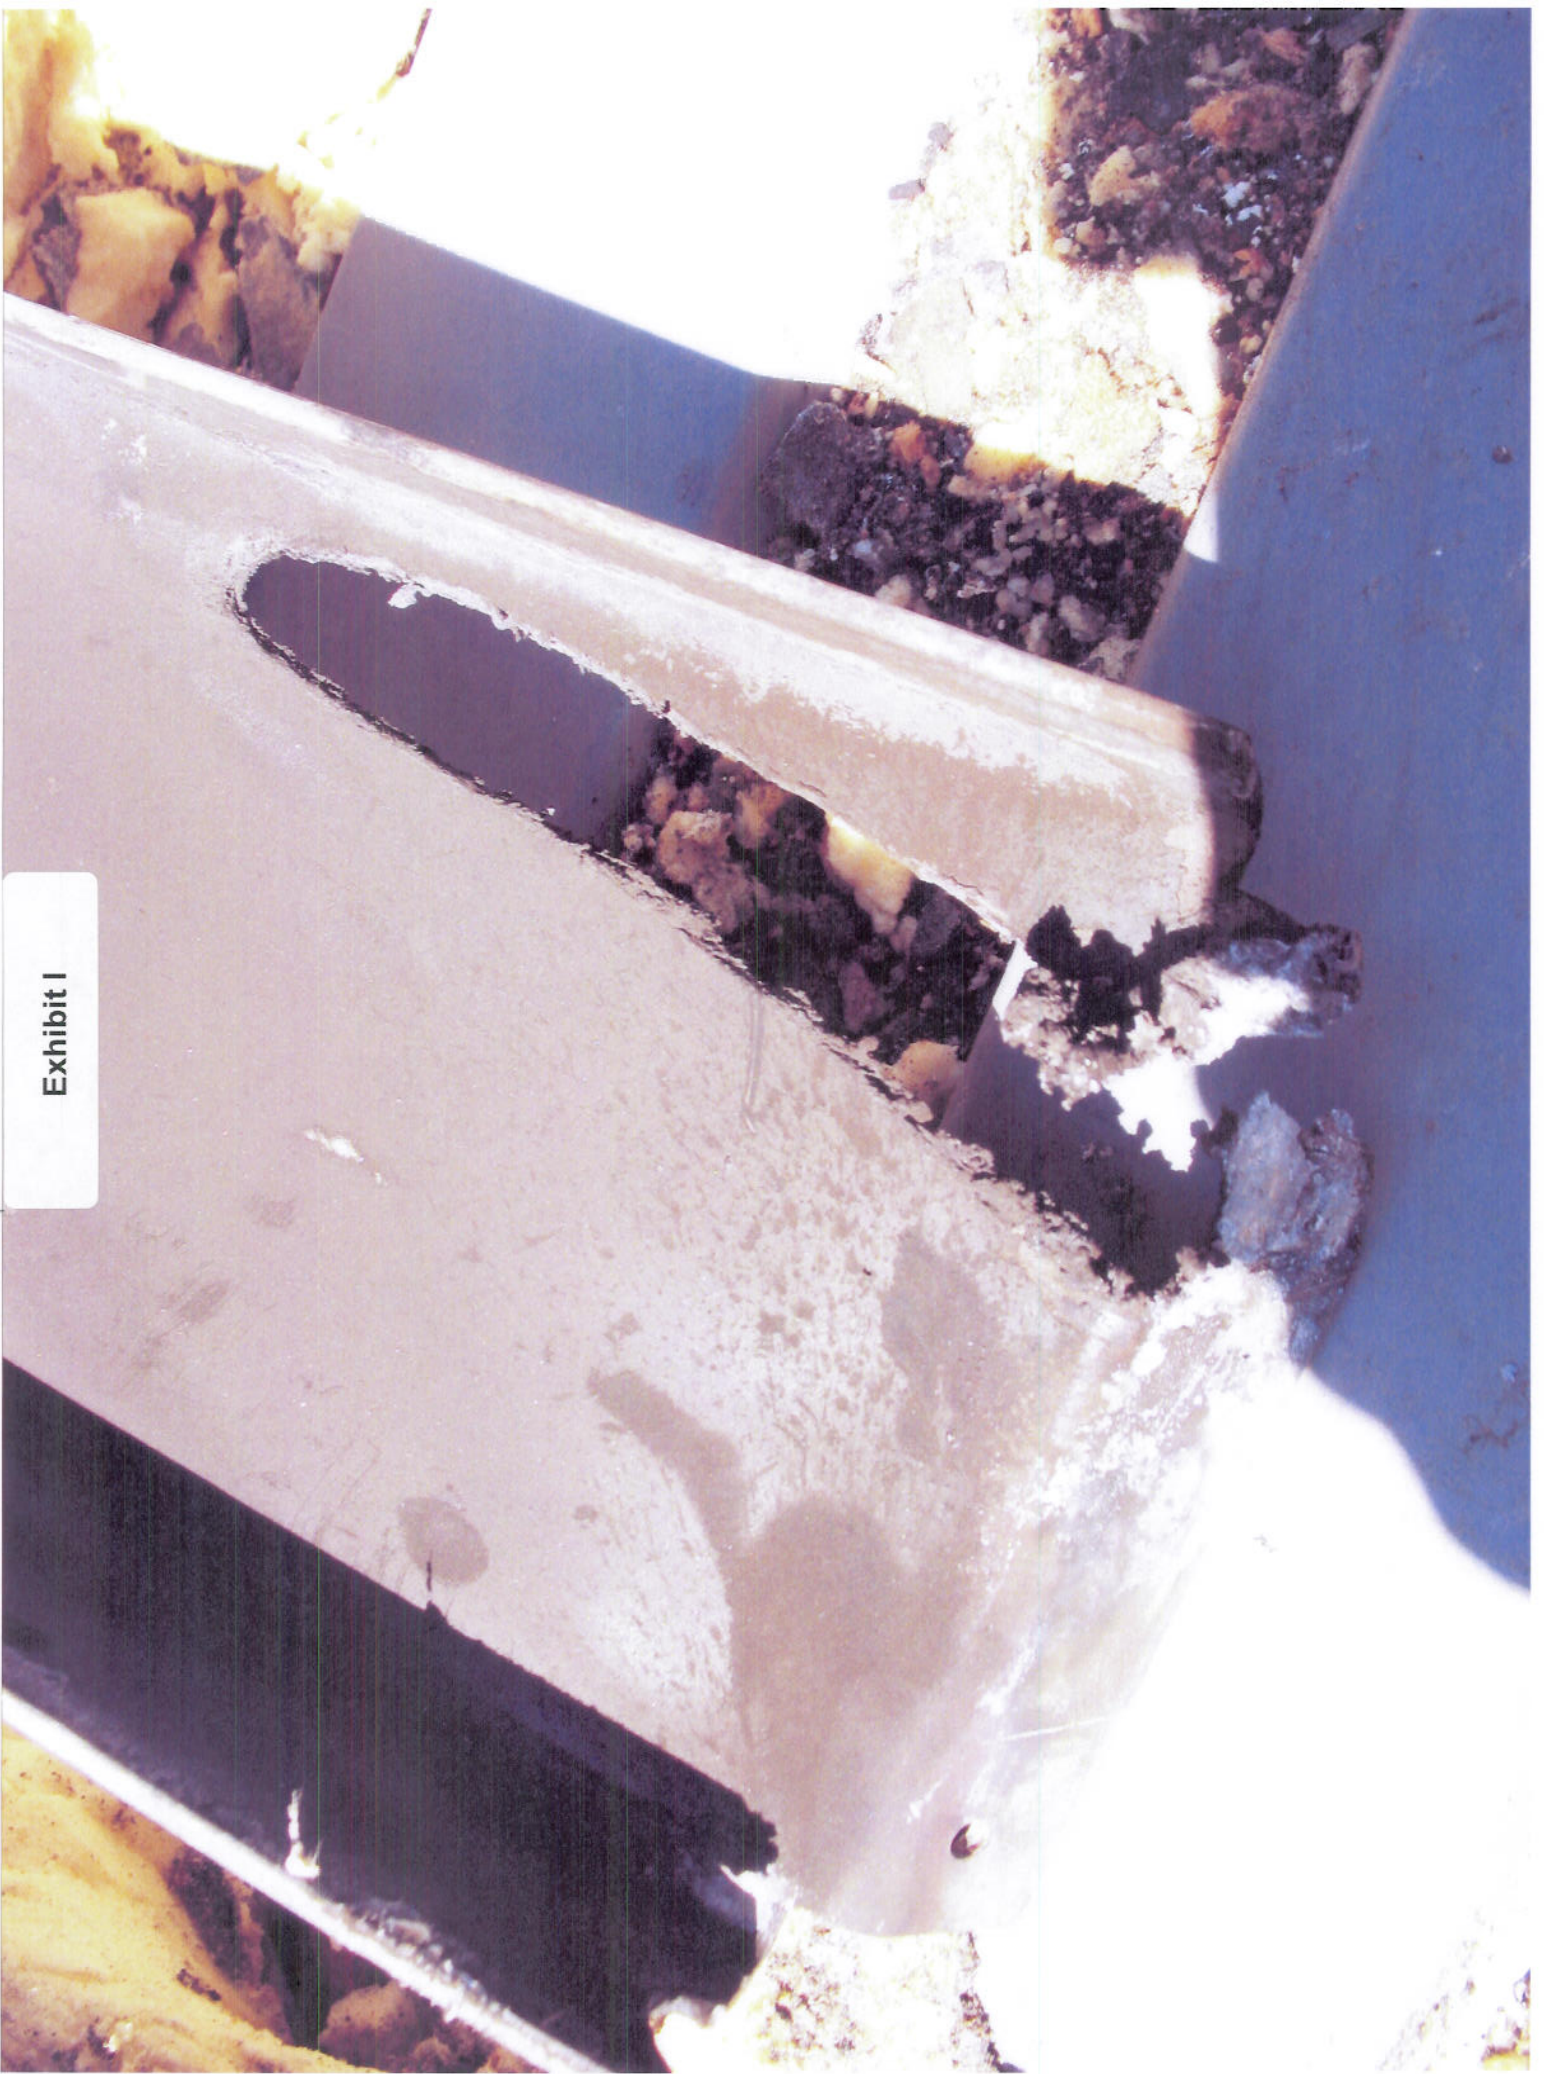
Exhibit I

- 1) The row of modules which burned was included in Sub Array 1. Massive arcing occurred in the lid of the metal raceway between this row and the next row of modules towards Combiner Box A1. **See Exhibits I and J.**
- 2) Combiner Box A1 is the 56 string box which included Sub Array 1. All fuses in this box were removed and checked for continuity. The following fuses were observed to have opened:

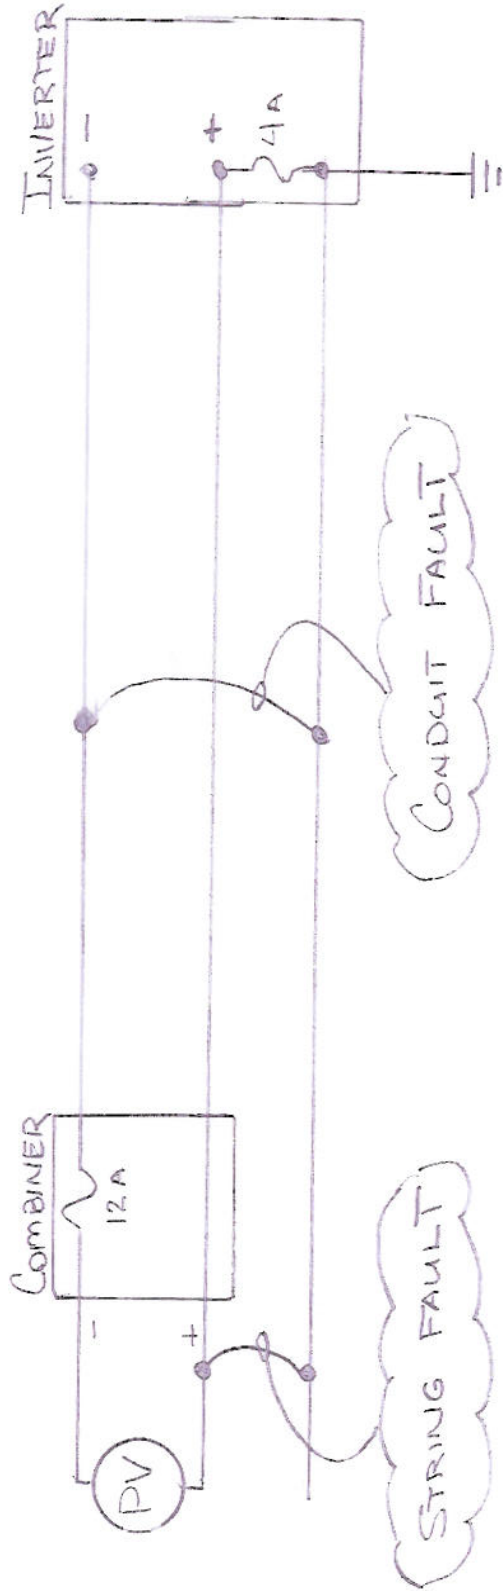
POSSIBLE FAULT CURRENT PATHS

The PV modules and associated mounting hardware were completely destroyed by the time the first responders arrived. Any evidence which the modules could have provided is gone. The metal channel raceways for the string conductors leading to and from the affected modules did survive along with the string conductors at these locations. There was major arcing between these string conductors and the metal channel raceway(s). Did the arcing cause the fire or did the fire melt the conductor insulation which then faulted to the metal channel raceway? There is no evidence that the fire was caused by any source other than the PV system at this point. There is no other source of heat on the roof or under the roof at this location. Arcing did occur here and would have started a fire with both the roof and PV modules. **The faulted conduit which caused Fire #1 would have been able to contribute fault current to the string conductors at this location.** The fact that both of these fires occurred at the same time does indicate that the fires were related. It is very possible that a low level fault in the string conductors was in existence at the module location for some time. A fault like this would occur when the string conductor insulation is damaged during installation. This fault would not necessarily rise to a level which would open the ground fault fuse at the inverter. A fault here could provide a path for current from the faulted conduit (Fire #1) once the ground fault fuse did open. There is no doubt that this contribution of fault current did occur during the event. It is probable there was an existing low level fault in these string conductors. This "existing" string fault would explain the current path(s) necessary for the two fires/faults in the two locations 200 feet apart. **See Exhibit N.**

- 3) Re-configure the strings and combiner boxes with a maximum 100 amp fused output for each. So that, a fault in one combiner output will result in the 100-amp fuse opening from reverse currents supplied by the other sources.
