Battery Explosion

Broadcast Message from the Sacramento Fire Marshall to a Fire Marshall's List Server:

Explosion In Rancho Cordova

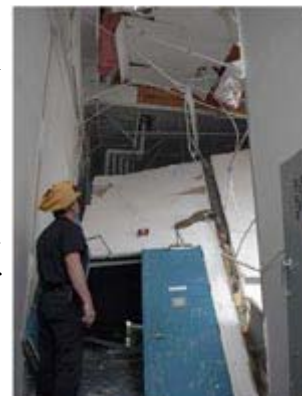
Thought some of you might be interested in this picture. It is a hydrogen explosion in a UPS/battery room we had here in Sacramento this week. It is a very good example of what happens if you lose ventilation in a battery charging room. The explosion blew a 400+ sq.ft. hole in the roof (notice the sky above in the picture), collapsed numerous walls and ceilings throughout the building, and significantly damaged a large portion of the 50,000+ sq.ft. building. Fortunately the computer/data center was vacant at the time, so there were no injuries. I have more pictures/info, if interested just let me know.

The lesson to pass on, is that ventilation is critical in these facilities. Great care should be taken to ensure ventilation is adequate, or even better that the batteries can not be charged without the ventilation system properly working. To complicate matters, the codes are not really helpful in these facilities - UFC Article 64 requires that continuous ventilation be provided or that system is designed in accordance with ANSI-IEEE 484. IEEE 484 unfortunately is very vague, does not prescribe set levels of ventilation, does not require interlocks, and even allow natural ventilation. IEEE 484 also specifically exempts the space from being a Classified (hazardous) electrical location. There are some other sections of UMC & UFC that could possibly be applied - but it could be quite a stretch. Since codes may not be enough, AHJ's may not be able to enforce adequate controls - therefore designers really need to pay close attention. If monitoring is used to activate ventilation, things are further complicated by the fact that there are not any thorough standards regulating the design or installation of gas detection systems. There are lots of good (and bad) ways to design and install battery rooms & critical ventilation systems, you just may have to look beyond the codes & standards. I've worked on a whole bunch of these - feel free to send any questions you might have in the future. Hope this

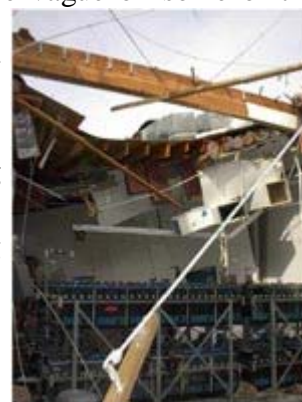
I received a lot of requests for more pictures & info - so I'll try to get it all in one email. I believe it is important to share information in the industry to prevent future incidents... but I'm also guessing this incident could result in some litigation, which I prefer to avoid, so I apologize if I'm a little vague on some of the specifics. The facility was formerly a large computer/data center w/battery room & emergency generators. The company vacated the building, moved out computer equipment, however the battery back-up system was left behind.

The ventilation for the battery room appeared to be tied into a hydrogen monitoring system (which is pretty common). The hydrogen sensor was in alarm upon emergency responders arriving at the scene (post-explosion). 911 callers reporting the explosion also reported hearing an alarm for 3 days prior to the explosion. This appears to have been a local alarm, as it was not relayed at any time to Fire Dept. Given how slowly batteries generate H₂ (1.3×10^{-7} m/s per ampcell), it appears as though batteries were charging for a long period of time with no ventilation - the detector was alarming, and hydrogen continued to build up until it found an ignition source. One could make their own guess as to why ventilation did not work. Due to the damage and actions of emergency responders shutting off all circuit breakers, etc., it could not be verified whether the ventilation system failed, or was previously turned off when the building was vacated. The best guess is that the ignition occurred at or near a grounding strap on the battery racks. But in a room full of batteries & electrical equipment, ignition sources are plentiful... especially when considering the sensitivity of hydrogen.
